# The impact of insufficient hydropower plant safety: A case study

M. Schwarzkopf, ILF Consulting Engineers Austria GmbH, Austria

This article highlights the example of a hydropower plant where insufficient due diligence during the implementation of a construction project led to serious damage, both to the hydropower plant itself and to the land affected by it. In particular, the paper emphasizes the discrepancies between the permit application design and the actual hydropower plant and pressure pipe that were constructed.

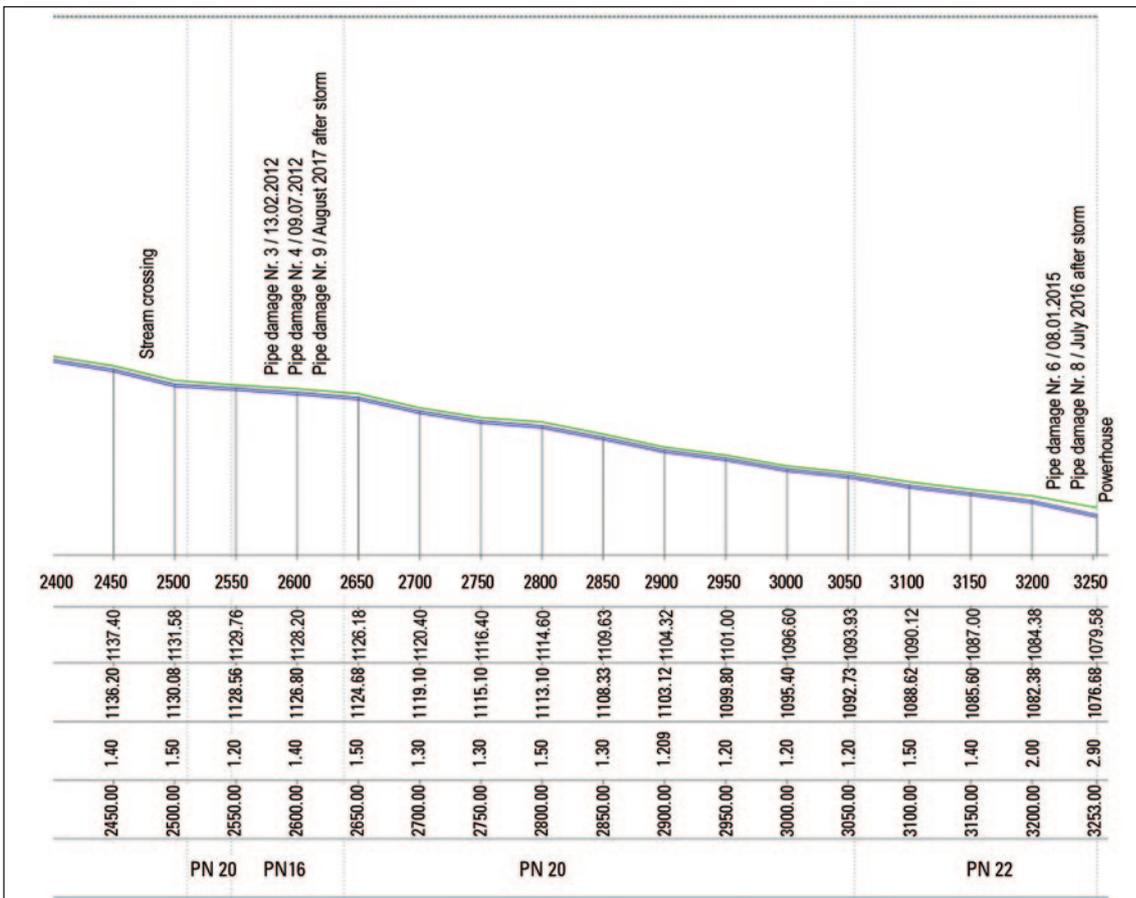
Another drawing by the operating company shows other discrepancies related to the pressure classes of the installed pressure pipes (see the last line of Fig. 1 where the pipe classes PN 20/PN 16/PN 20 and PN 22 are indicated).

It can be inferred from this that in the area of damage no. 10 at chainage km 2590 (660 m upstream of the powerhouse, on a length of about 100 m), PN 16 pipes have

Fig. 1. Detail from drawing depicting pipe damage incidents (prepared by the operating company).

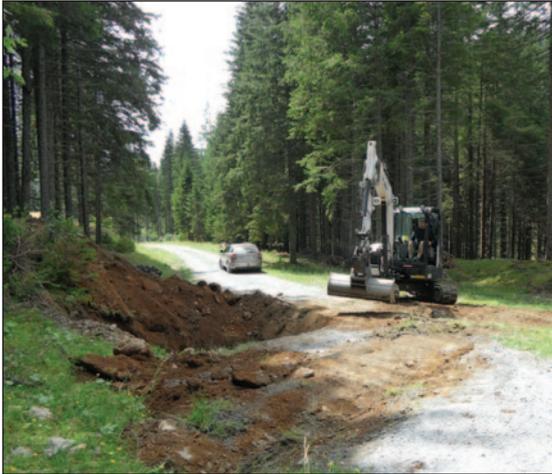
(a) Excavation works for uncovering the pressure pipe in the summer of 2019.

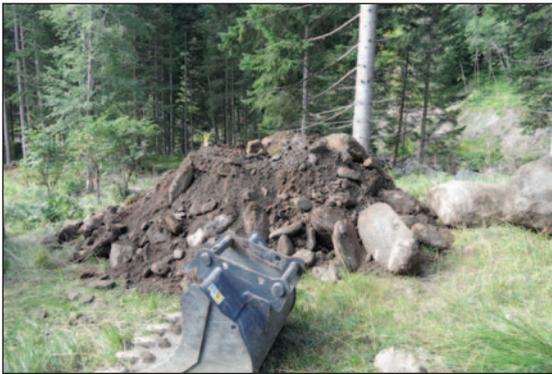
(b) Excavation material of the pipe trench with rocks of up to 1 m in diameter, in the summer of 2019.

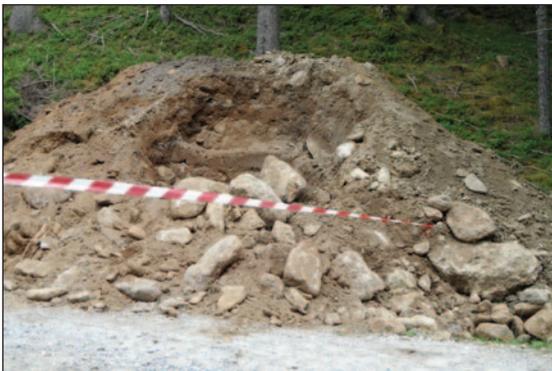
(c) Excavation/backfilling material of the pipe trench with rocks of up to 1 m in diameter, summer of 2019.

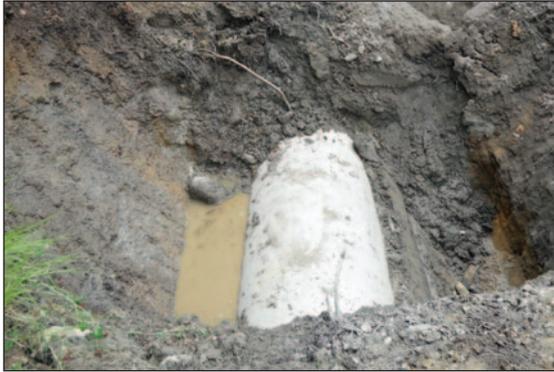
(d) Accumulation of groundwater on the embankment side after approx. 24 h in dry weather conditions (no drainage), in the summer of 2019.

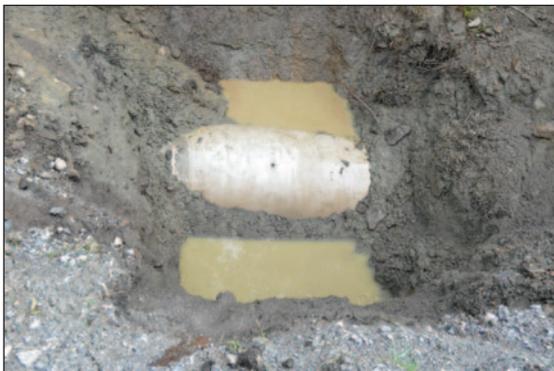
(e) Accumulation of groundwater and stormwater in the pipe trench about 48 h after rainfall event (no drainage). Same location as in Photo (d), summer of 2019.

codes of practice and the manufacturer's laying guidelines: the material for the lateral backfilling was not chosen according to general codes of practice; instead of using gravel size 16/32, cohesive or partly cohesive material was used as lateral backfilling material; drainage installations were obviously not installed (especially noticeable at location 3 of the uncovered pipe), see also Photos (d) and (e); and, soil replacement as specified in the requirements stipulated in the permit was not carried out.

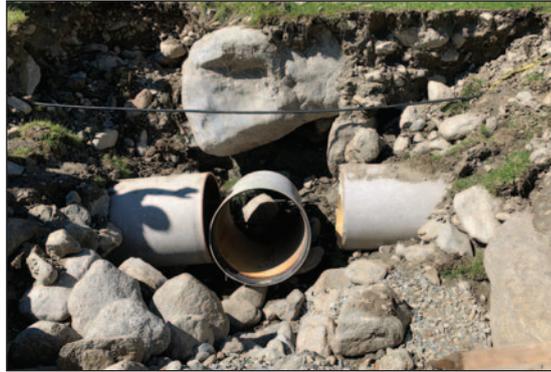
When uncovering the pressure pipe in the summer of 2019, there was no evidence of the above-mentioned uniform layers in the backfilled pipe trench containing the GRP pipe. In fact, it became evident that in the course of laying the GRP pipe, the trench had been backfilled with the initial excavation material, which had not been properly prepared. There were no indications of any limitation to maximum grain size, pipe bedding and drainage works, as specified in the manufacturer's laying guidelines and in the permit application design documents, in any of the uncovered places.

(f) Pipe damage incident no. 10 (no bedding material and unsuitable backfilling material), August 2019.

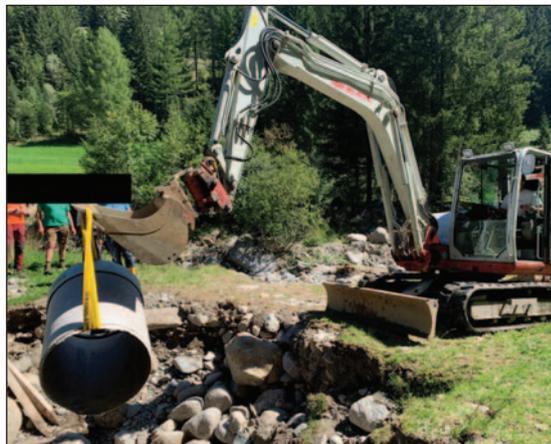
(g) Pipe damage (excavation works), August 2019.

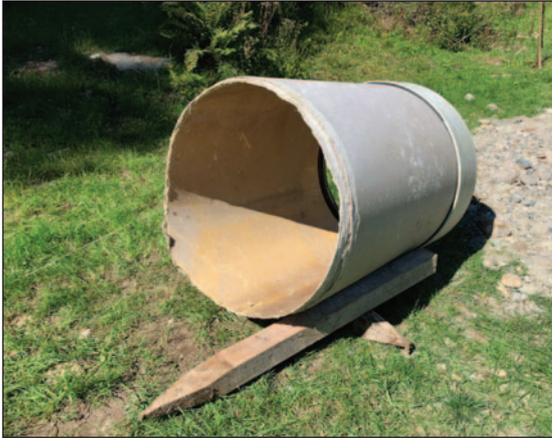
(h) Pipe damage (broken pipe), August 2019.

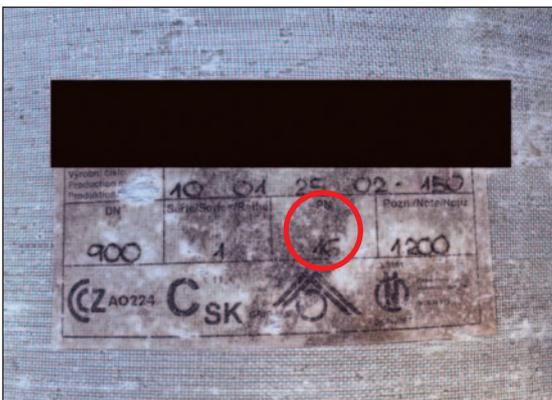
been laid from km 2550 to km 2650. A check of the pressure conditions in this area showed the static pressure to be about 154 m water column (water level at intake at about el. 1280 m and pressure pipe approximately el. 1126 m) where damage occurred in August 2019.

The fact that pipes of pressure class PN 16 were installed in the mentioned area as confirmed by checking the pipe class during the repair works in this section, see also Photo (i), is not reasonable from a technical point of view, as a PN 16 pressure class is only nearly sufficient in terms of safety for the static pressure load of 154 m water column. But furthermore, no additional dynamic pressure fluctuations were taken into account in the permit application design. For example, there are no transient analyses for the system or any other sufficiently reasonable pressure surge estimates for the pressure pipe system.

(i) Broken pipe, see photo (h) with specification sticker on pipe (pipe class PN 16 at a static pressure of 154 m water column), August 2019.
